**MARYLAND HISTORICAL TRUST  
DETERMINATION OF ELIGIBILITY FORM**

Property Name: Maintenance Buildings (3), Rosewood Hospital Inventory Number: BA-2277  
Address: Rosewood Hospital City: Owings Mills Zip Code: \_\_\_\_\_  
County: Baltimore County USGS Topographic Map: Reisterstown  
Owner: DHMH Is the property being evaluated a district? ☐ yes  
Tax Parcel Number: \_\_\_\_\_ Tax Map Number: \_\_\_\_\_ Tax Account ID Number: \_\_\_\_\_  
Project: \_\_\_\_\_ Agency: \_\_\_\_\_  
Site visit by MHT staff: ☒ X no ☐ yes Name: \_\_\_\_\_ Date: \_\_\_\_\_  
Is the property is located within a historic district? ☒ X yes ☐ no

Rosewood Maintenance Buildings

## State Historic Sites Inventory Form

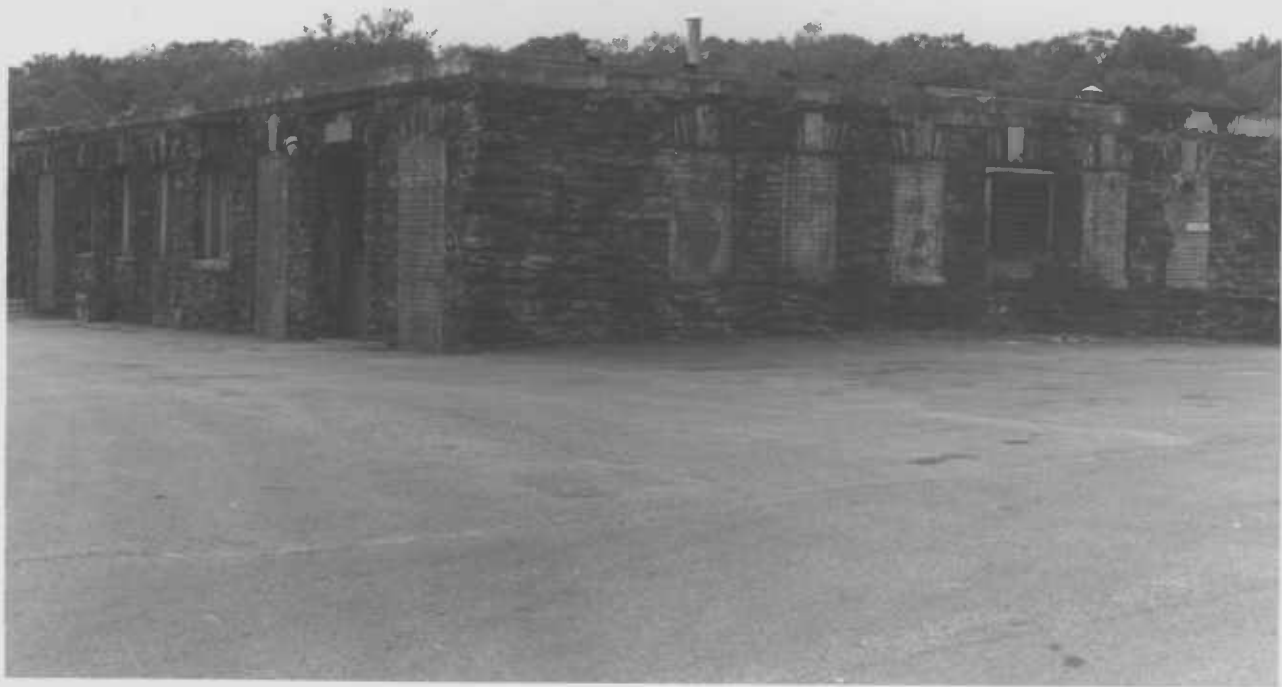
Rosewood Maintenance Buildings - Machine  
Shop

The Maintenance Shop (Key Shop) - is a one-story, flat-roofed, ten bay long building constructed of dark, rough-cut stone. The windows and doors have segmental arches; many have been bricked-in. The interior has been altered.

Southeast Elevation

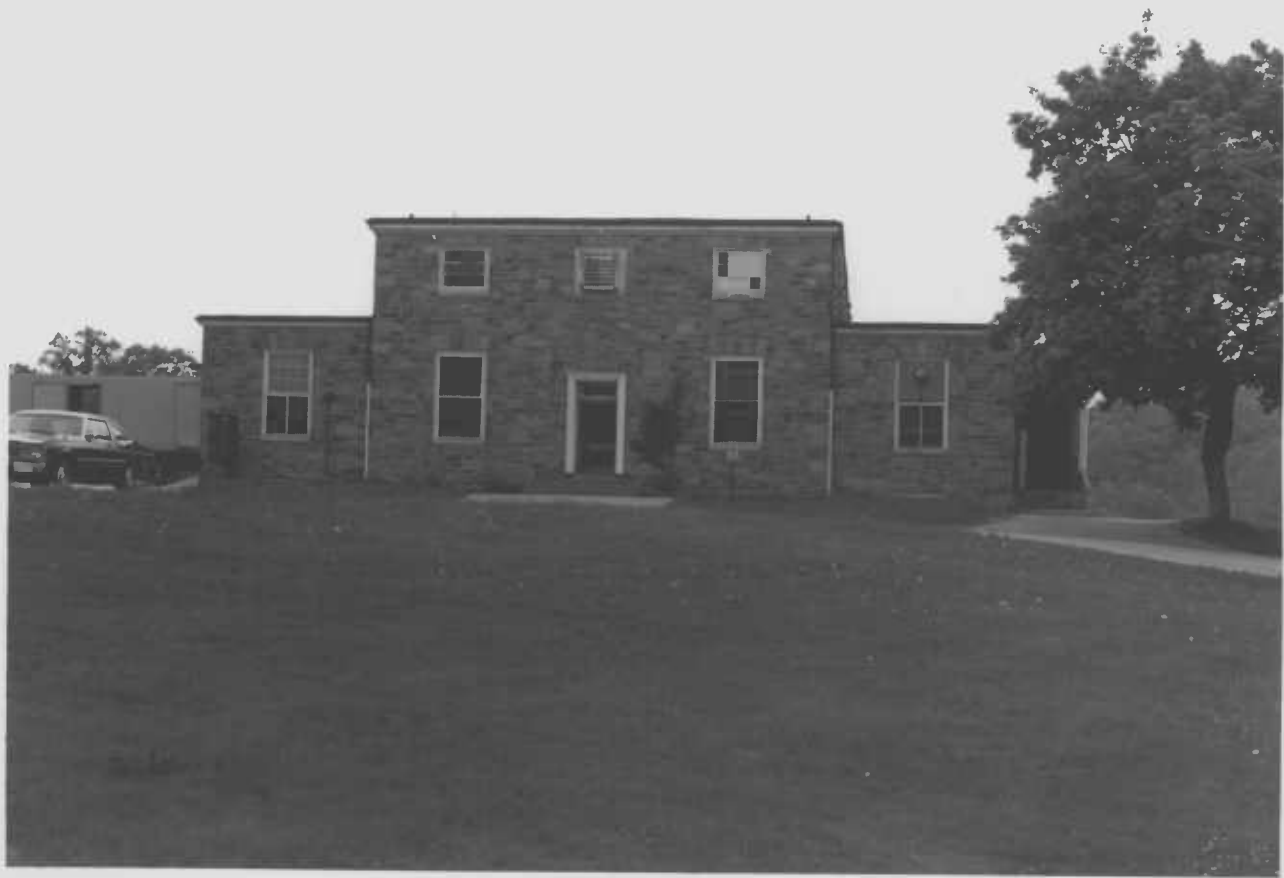
Rosewood Maintenance Buildings - Laundry/  
Garage

The Laundry and Garage - is a one-and-one-half-story stone building constructed on the side of a hill with a garage entrance on the fully exposed north basement facade. It is very similar in design to the Dining Hall and Kitchen Building and is constructed of variegated cut stone with smooth-faced cut stone used for the projecting window sills and jack arches above the windows. There is an entrance on the east facade with a pedimented portico supported on square Doric piers. There are 12/12 sash windows on the first story and nine-pane fixed sash windows on the second story. The interior is unaltered but is otherwise of no significance. The Baltimore architect Henry Powell Hopkins was responsible for the design of this building which was completed in 1941.

East Elevation

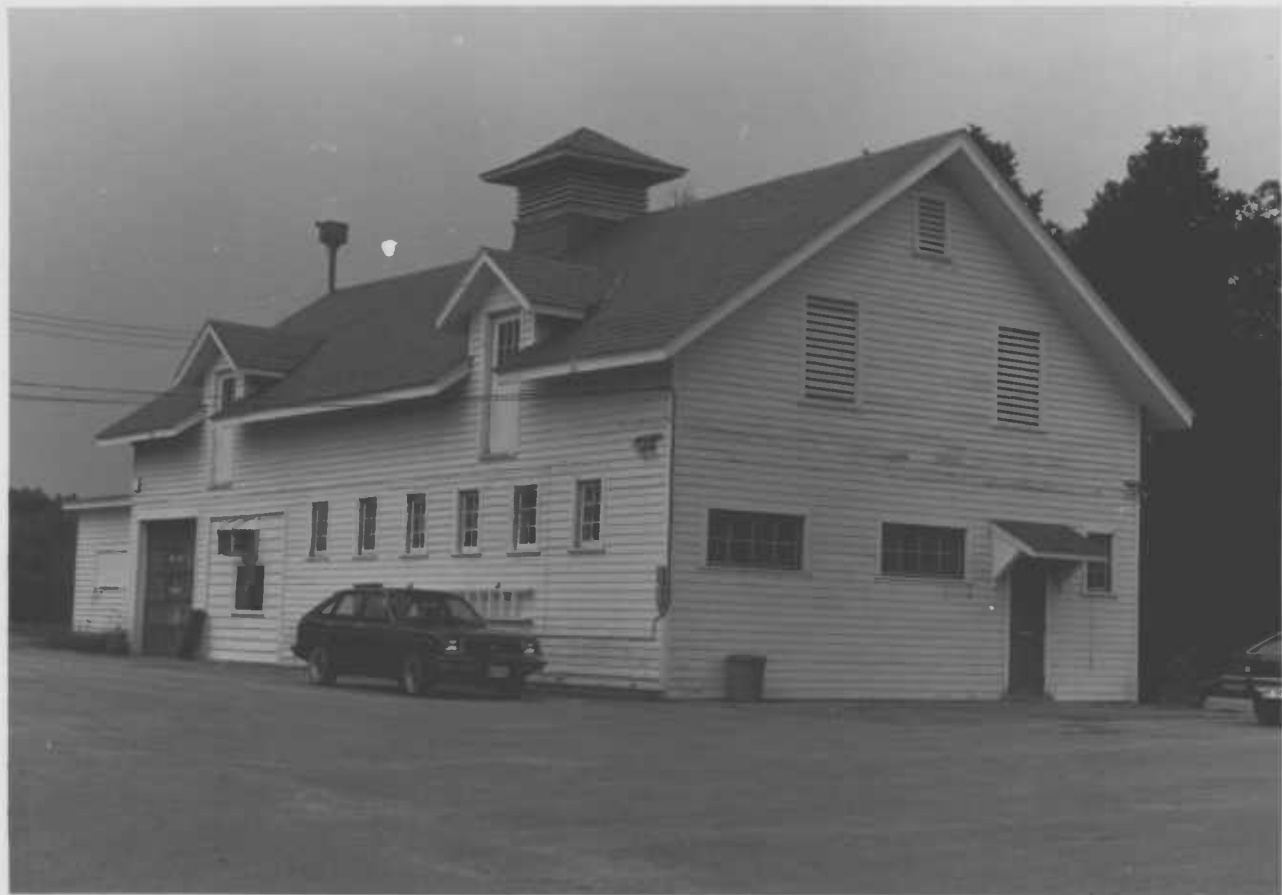
Rosewood Maintenance Buildings - Fire House

The Fire House (Horse Stable) - is a two-story, gable-roofed frame building with louvered windows on the gable ends and large stable doors on the north-west corner and south facade. There are two pedimented dormer windows which break through the roof eaves on the east and west facades, and a cupola with pyramidal roof in the center of the roof. The building was constructed in 1913 as a horse-stable but was converted for use as a fire-house in the 1950s.

Southwest Elevation
